Fall Edition Sept - Nov, 2006

The Sentry is a publication of Sentry Watch, Inc. All rights reserved, 2006. The information contained herein is for informational purposes only and not considered a substitute for legal counsel or advice.

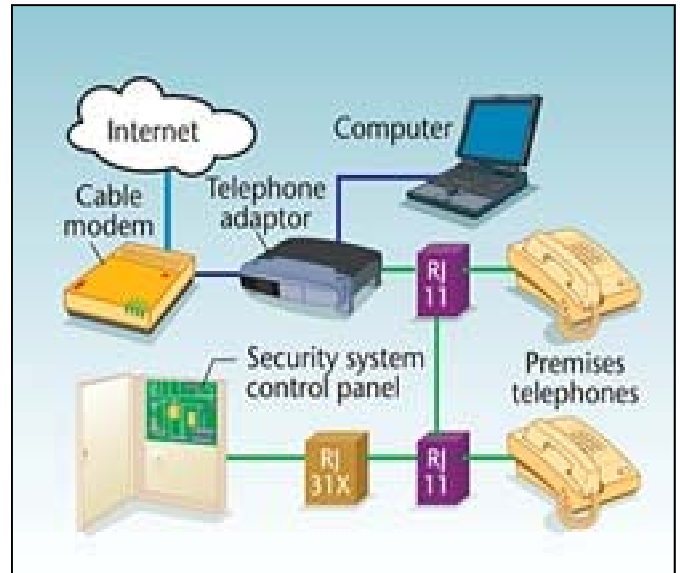
One residential customer changed his telephone service to VoIP as shown in this diagram (right) with a self-install kit. After switching to VoIP, the digital communicator had intermittent problems transmitting signals to the monitoring office. Can you see what is causing the troubles and what they can do to correct the problem?

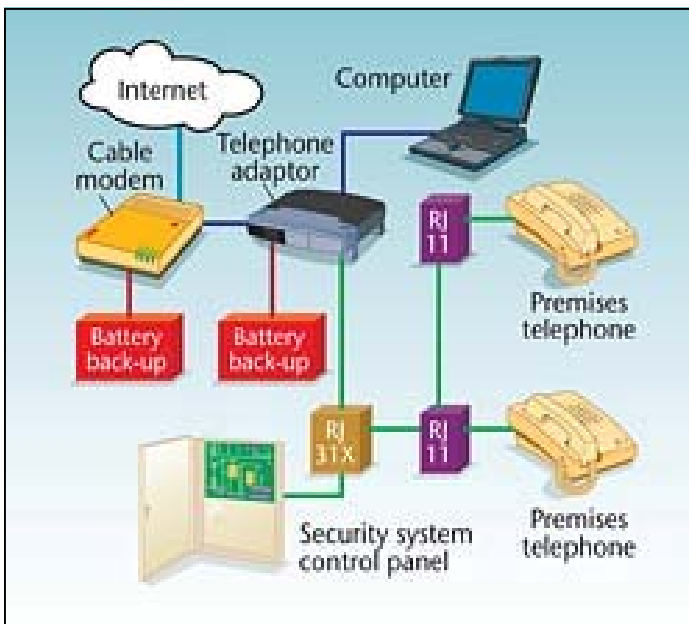
Customer's problem most likely is caused by the "backfeeding" method used to connect the output of the telephone adaptor to the internal telephone wiring. This technique puts the RJ-31X jack at the end of the internal wiring rather than at the beginning, preventing the communicator from seizing the telephone line when a signal has to be sent. They should rewire the telephones as shown in this diagram and recheck the dialer. They also should make sure that backup battery power is provided for the modem and telephone adaptor in case of power outage.
